BUILDING STANDARDS COMMISSION

SPECIAL MEETING

## STAFF REPORT

Case #: 20220020

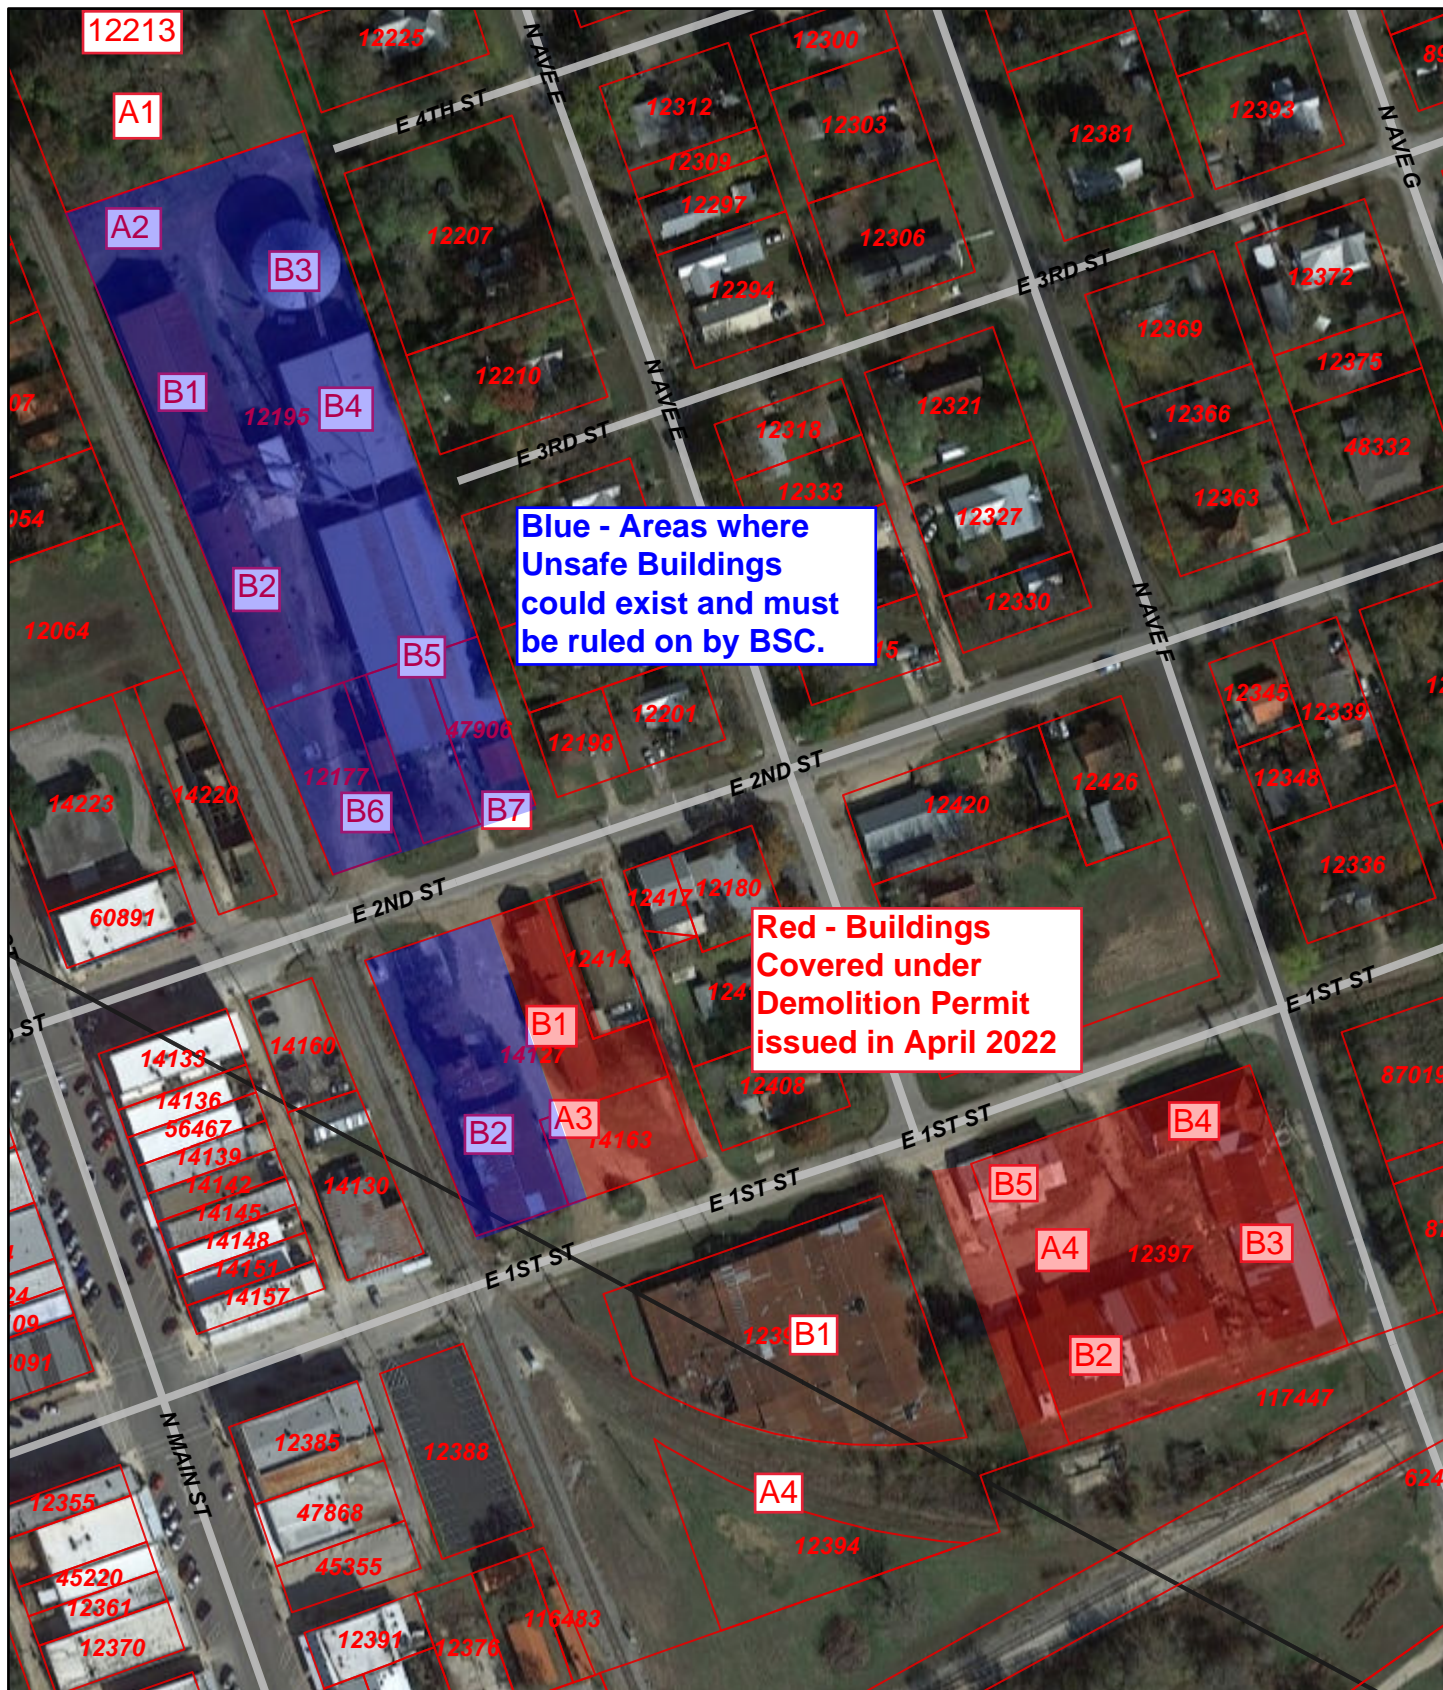
Attachment 4  
Site Area Map

**Blue - Areas where Unsafe Buildings could exist and must be ruled on by BSC.**

**Red - Buildings Covered under Demolition Permit issued in April 2022**
